# South Rybolt Area Survey

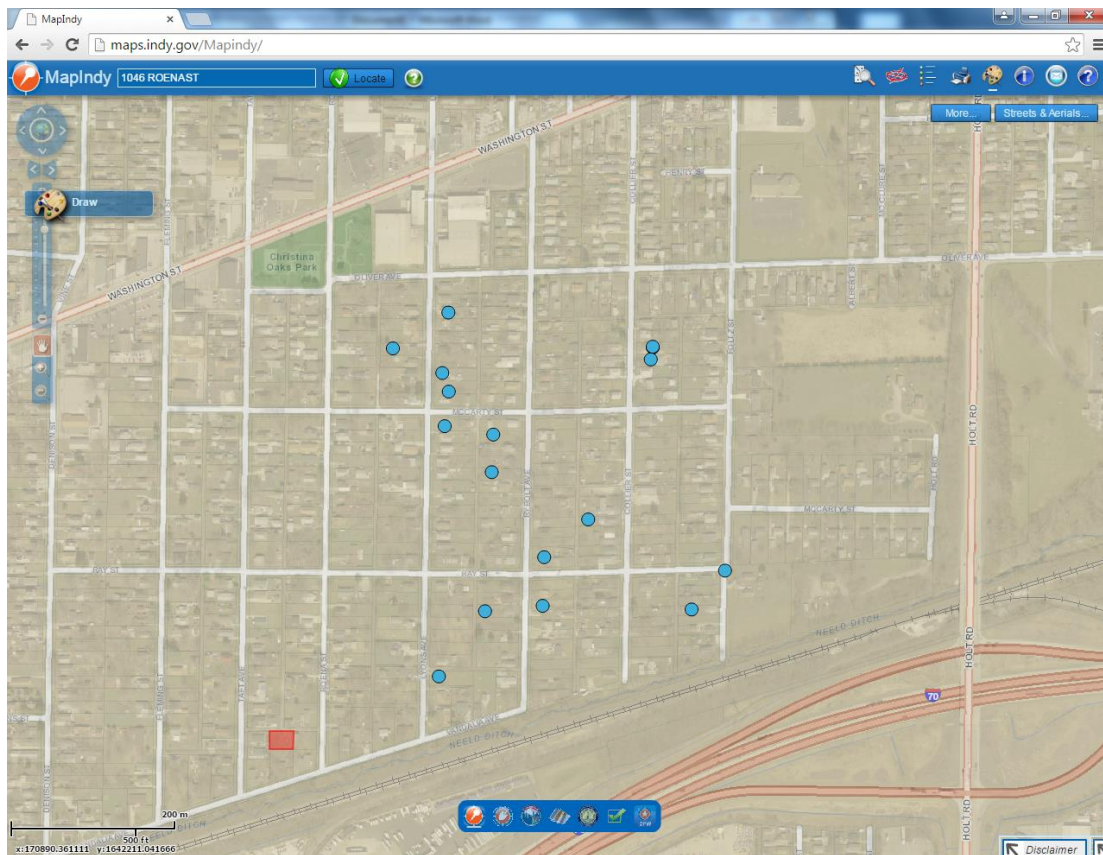
Map 2. Locations of wells sampled

There were sixteen wells that were sampled during the study. Fourteen of the wells had bacteriological contamination, one of which contained *E.coli*. The property with *E.coli* contamination was chlorinated and the follow up sample was satisfactory. Chlorination instructions were sent out with the lab reports and follow-up inspections were scheduled.
